# Manhole Inspection Summary

Manhole # S23E1\_003MH

Insp Date: **7/23/08 10:13 AM**

**Location** Address: **across from 2460 Hollins Ferry RD**

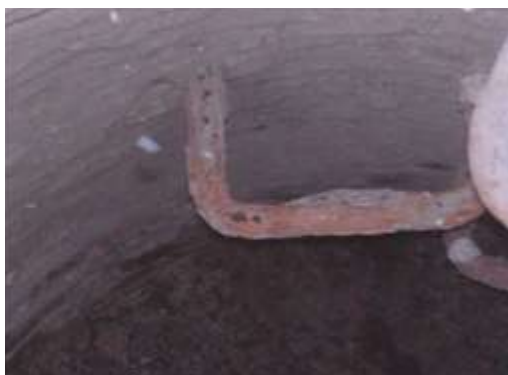
Defect 2

Count: **3** Missing: **0** ☒ **Corroded**

corroded rung

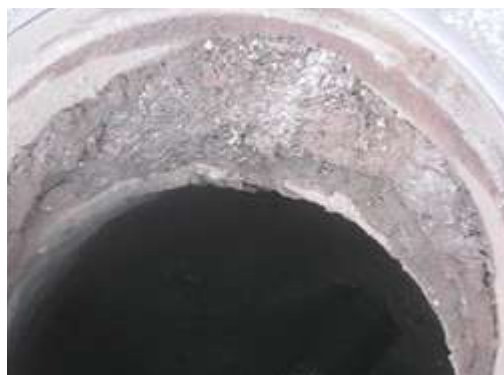
Defect 1

Offset: **4** (in.)

Condition: ☐ Sound ☐ Cracked ☒ **Leaks**

Condition: ☐ Sound ☐ Cracked ☐ Root Intrusion ☐ Loose Brick ☒ **Deteriorated**

Infiltration: ☐ None ☒ **Joint** ☐ Cracks ☒ **Mortar** ☐ Roots ☐ Wall

frame leaks & offset 4"; chimney deteriorated with signs of flow at joint/mortar

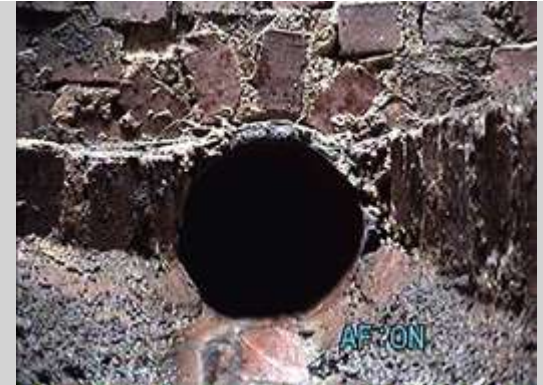
12 O'Clock Outflow

8 in. Circular Gravity Sewer  
Pipe Out @ 12 O'Clock

Pipe Height: **8.4** (in.) Rod and Bar (Angled)  
Pipe Material: **Clay** ☐ Pipe Lined  
Invert Depth: **7.50** (ft.) Flow Characteristics: **Fast**  
Deposits: ☒ None ☐ Mud ☐ Sludge ☐ Debris ☐ Grease  
Silt Depth: **0** (in.) Deposits Extent:  
Infiltration: **None** Pipe Seal Cond: **Sound**

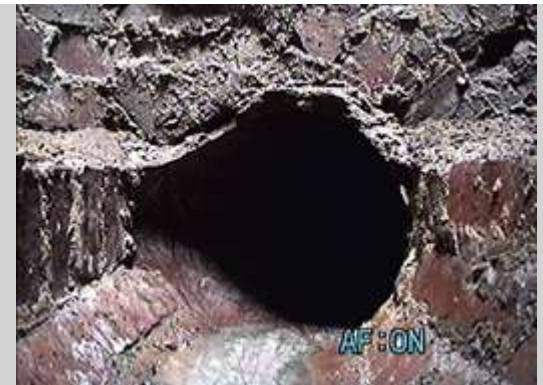
7 O'Clock Inflow

8 in. Circular Gravity Sewer  
Pipe In @ 7 O'Clock

Pipe Height: **9.6** (in.) Rod and Bar (Angled)  
Pipe Material: **Clay** ☐ Pipe Lined  
Invert Depth: **7.37** (ft.) Flow Characteristics: **None**  
Deposits: ☒ None ☐ Mud ☐ Sludge ☐ Debris ☐ Grease  
Silt Depth: **0** (in.) Deposits Extent:  
Infiltration: **None** Pipe Seal Cond: **Sound**

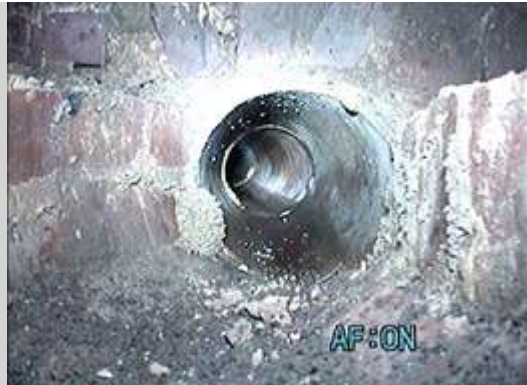
9 O'Clock Inflow

Pipe In @ 9 O'Clock

Pipe Height: **8.4** (in.) Rod and Bar (Angled)

Infiltration: **None**

Pipe Seal Cond: **Sound**
